**Navigation Study at the Approach
to Lock and Dam 24,
Upper Mississippi River**

**Hydraulic Micro Model
Investigation**

Technical Report M2

Final Report - January 1998

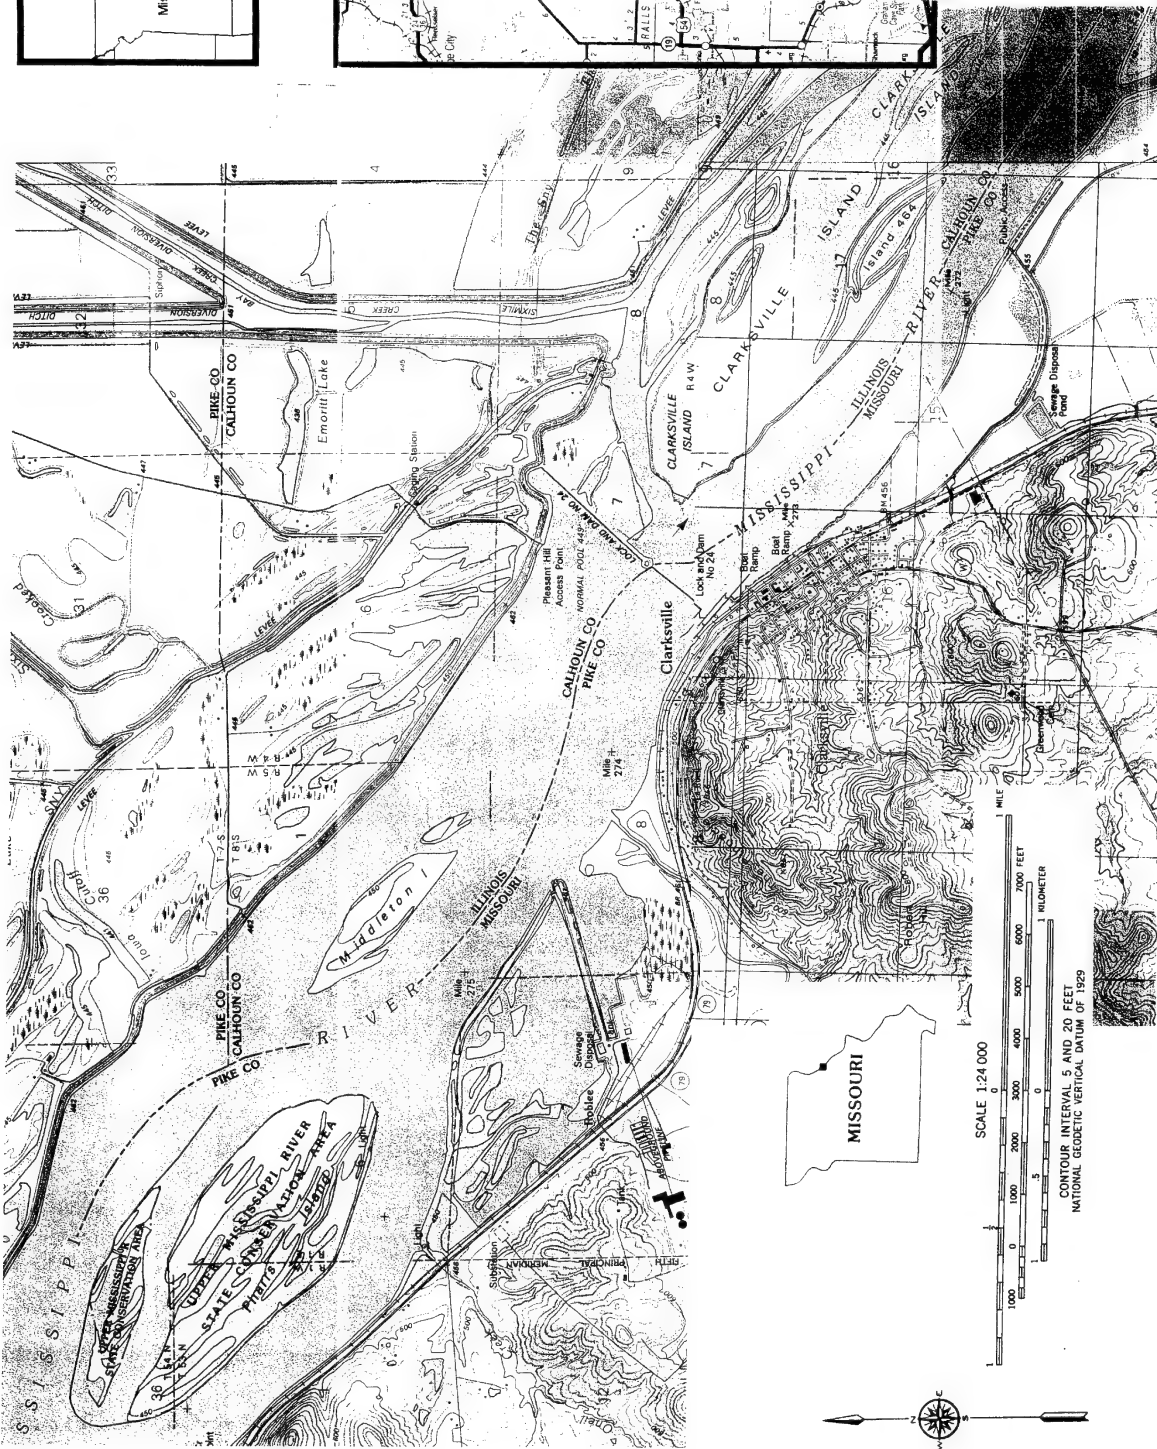
This report details the investigation of a sedimentation and flow study of the Upper Mississippi River using a physical hydraulic micro model. The micro model methodology was used to evaluate detrimental flow conditions experienced at the downbound navigation approach to Lock and Dam 24, Mile 273.5R, at Clarksville, Missouri. Plate 1 displays the vicinity map and USGS quad sheet of the study reach. Plate 2 is a photograph of Lock and Dam 24.

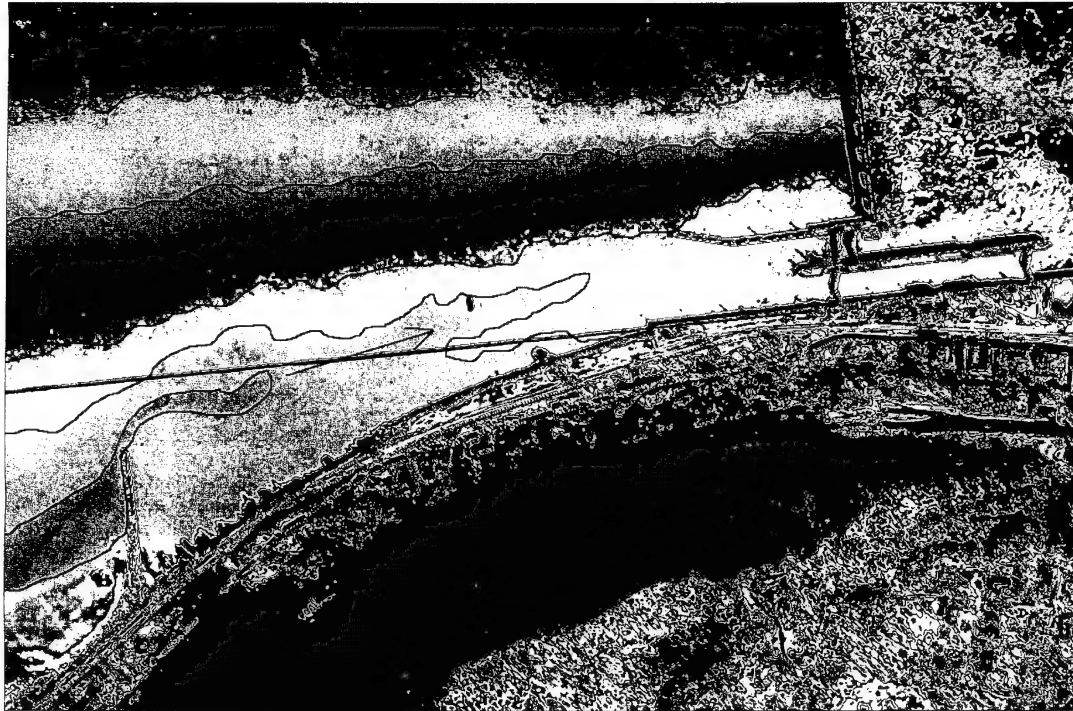
Plate 14 shows the original color aerial and the color-enhanced aerial from a standard image processing software package. Visual comparison between the two images showed a distinct variance in color. This represented the effects of surface roughness and suspended sediment.

The remote sensing analysis revealed two important trends. First, it could be seen that currents deflected off the tip of dike 274.0R, as expected. Second, however, it could be visualized that both the deflected currents off the dike tip and the currents within the downstream shadow of the dike were pulled toward and then away from the apex point of the rock bluff protrusion. This visualization of current deflection at the bluff was verified by observations from the ADCP data (Plate 11).

openings. These trends were similar to what was observed from the ADCP and remote sensing prototype data (Plates 11 and 14).

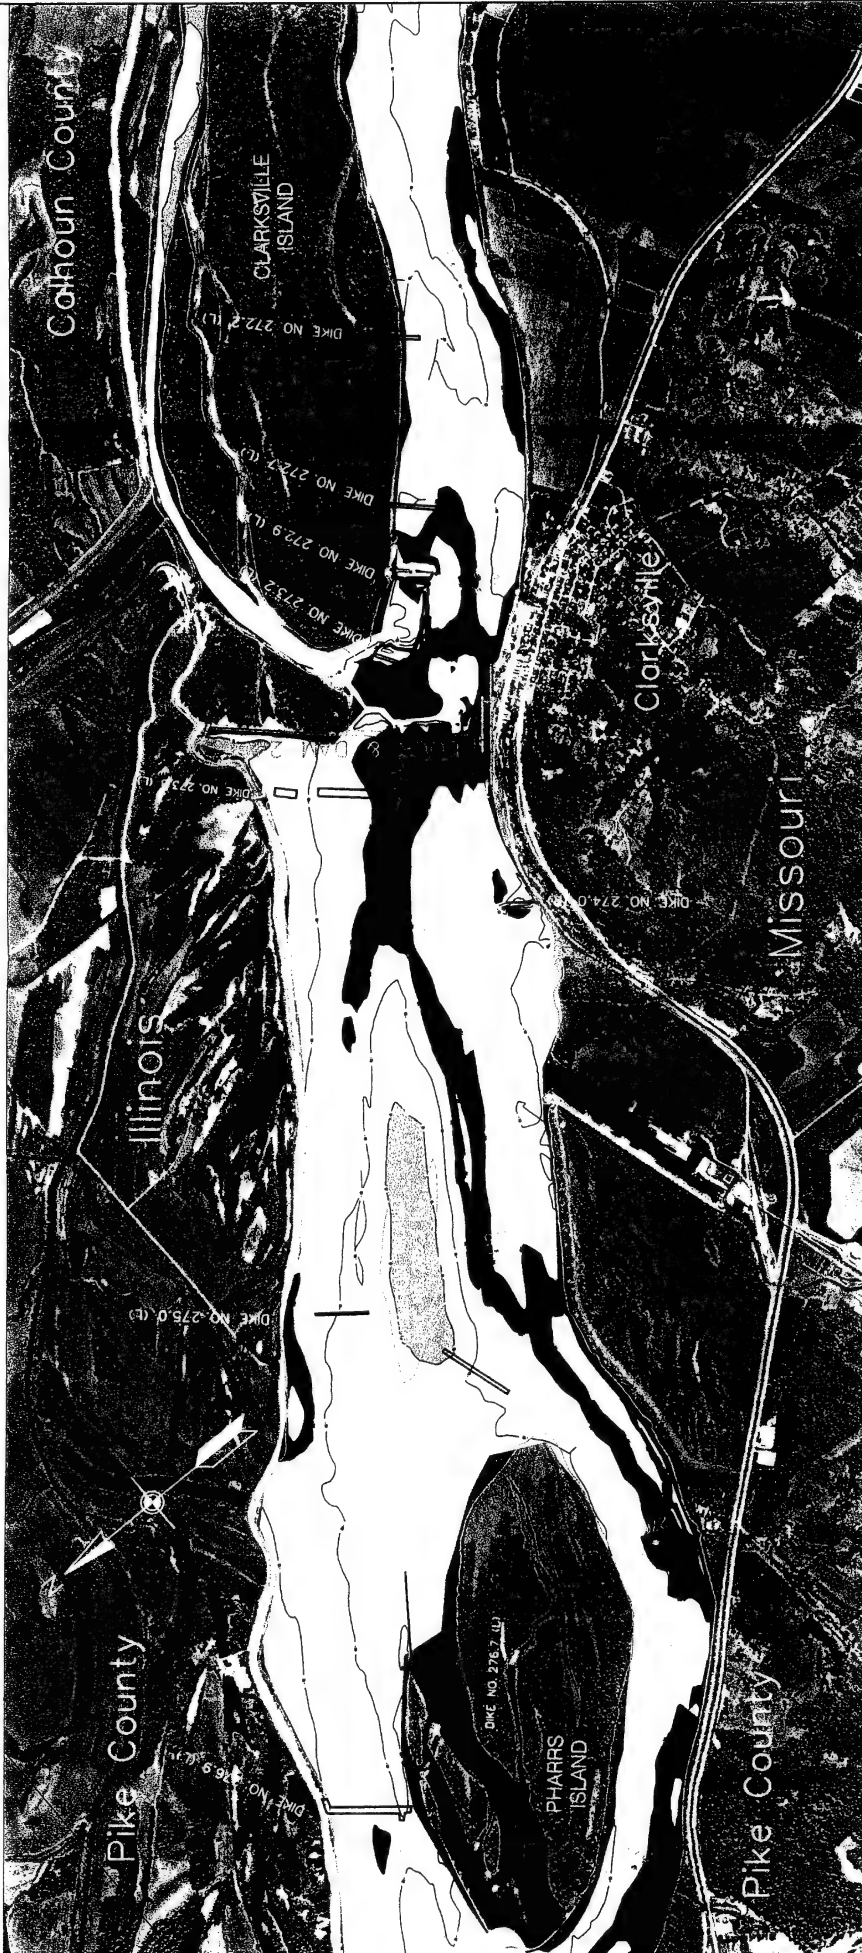
Plate 25 shows the resultant bed configuration of the micro model base test. This survey served as the comparison survey for all future design alternative model tests. The base test was developed by simulating steady flow or open river conditions until bed stability was reached.

Generally, the bathymetric trends established in the micro model were very similar to the trends observed in the historical prototype surveys. The only major noted difference was the location of the scour hole pattern below the dam. The scour had a tendency to occur further downstream in the model as compared to the prototype.
